Fujitsu Microelectronics Europe
Functional Limitation Report

32-BIT MICROCONTROLLER **MB91460 SERIES**

FUNCTIONAL LIMITATION
EXTERNAL INTERRUPT
2006-11-27

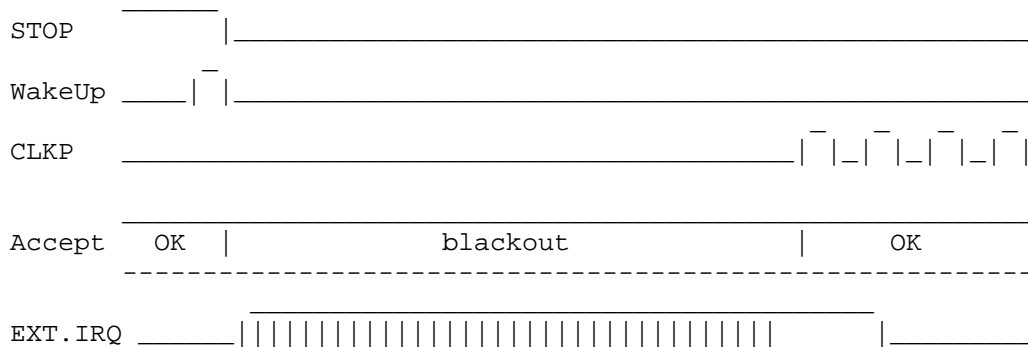
4 Root Cause

The problem occurs in the in the following constellation:

- MCU is waking up from STOP mode by either external interrupt trigger or internal RTC interrupt trigger (WakeUp)
- Oscillation stabilisation wait time is elapsing before internal clocks (CLKP) are feed-in to the external interrupt module
- The time frame between wake up trigger and the internal feed-in of clocks is called 'black out time'
- If one or more external interrupt events are supplied in the 'black out time' they neither set the related interrupt request flag nor start the interrupt processing (i.e. they are not accepted)
- The duration of the 'black out time' is depending on the selected oscillation stabilisation wait time (STCR_OS0, STCR_OS1) plus a fixed part of about 80us (for internal processing and regulator start up).

- The application uses only one interrupt source (either RTC or external interrupt) as wake up trigger
- The external interrupt signal needs to be long enough (in case of level) to be active after the black out time
- The external interrupt signal needs to be elongated by appropriate external circuitry (e.g. monoflop) in case of short pulse
