32-BIT MICROCONTROLLER **MB91360 SERIES**

FUNCTIONAL LIMITATION
CAN INTERRUPT SETTING

2009-03-27

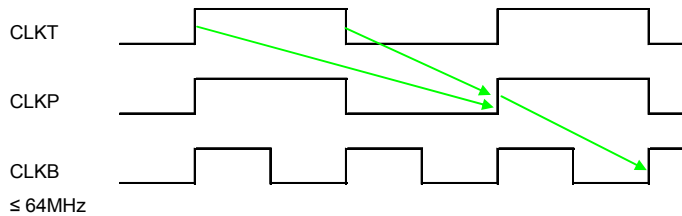
5.1 Correct function (e.g. configuration with CLKP:CLKT even divider):

There is no short path for $CLKB \leq 64MHz$ (green arrows).

CLKT is synchronizing CAN interrupts from CAN clock domain (asynchronous to core domain) to core clock domain, interrupts to Interrupt Unit (I-UNIT) are output on both rising edge and falling edge CLKT (due to IRQ latency performance). CLKP is capturing the interrupt signal within Interrupt Unit (I-UNIT) and providing Vector/Level to CPU (CLKB domain).

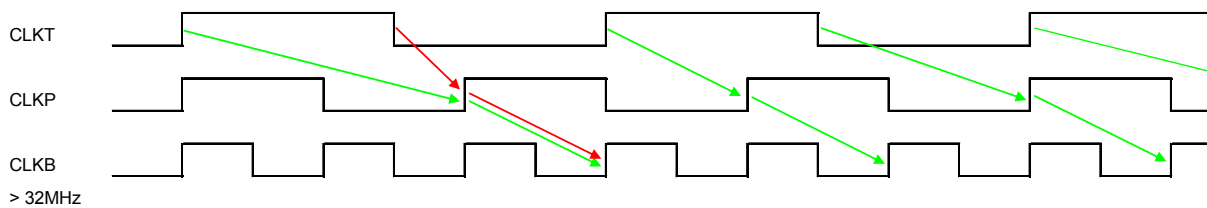
5.2 Incorrect function (e.g. configuration with CLKP:CLKT odd divider):

There is a short path for $CLKB > 32 MHz$ (upper red arrow).

Time between falling edge CLKT to rising edge CLKP is too short (upper red arrow), wrong Vector/Level might be provided to CPU, possibly causing wrong ISRs (of possible interrupt numbers 16-79 decimal) to be executed.

The occurrence of spurious interrupts is based on signal path delay between CAN interrupt synchronizer module and interrupt unit output registers. Therefore the probability of occurrence will increase with increasing temperature.

- **Set register bits in CREG register E_INT = 1 and S_INT = 1**

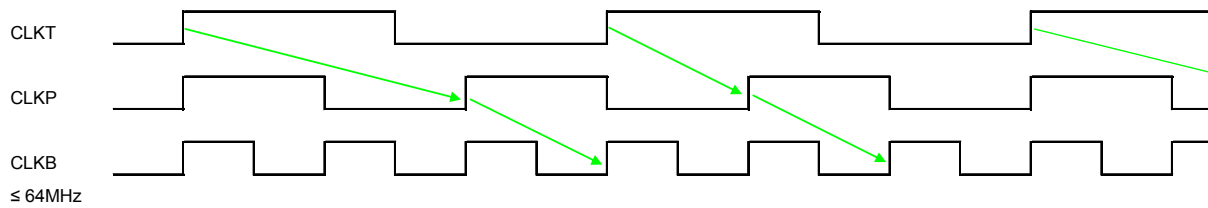
6.3 Workaround function (e.g. configuration with CLKP:CLKT odd divider):

There is no short path for $CLKB \leq 64MHz$.

Interrupts are only output with rising edge CLKT to Interrupt Unit (CLKP domain) - a short path between CLKT and CLKP is prevented.

Drawback of the proposed workaround is the slightly higher interrupt latency. But it is judged as negligible for small division ratios of CLKP and CLKT. In above's example with $CLKB:CLKP:CLKT = 1:2:3$ there are only a maximum of 2 additional core clocks (CLKB) necessary.
