16/32-BIT MICROCONTROLLER
MB9FXXX

HANDLING NOTE
DATA POLLING FLAG DURING FLASH
SECTOR ERASE

2009-05-25

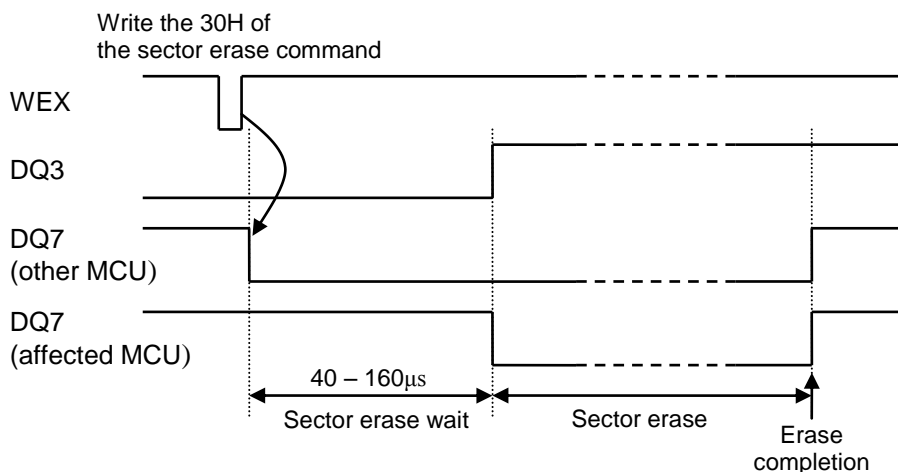
Figure 1: Operation of DQ7 and DQ3

After submitting a sector erase command (writing of the last command ‘30H’), the Flash enters the ‘sector erase wait’ state for 40-160µs, what is indicated by DQ3=0. During this time the Flash waits for further erase commands (to erase multiple sectors at one time). The actual erase operation is started after this time (when DQ3 changes to ‘1’).

During this ‘sector erase wait’ state, the data polling flag DQ7 outputs ‘1’ in affected MCUs. DQ7 changes to “0” with entering the actual erase state.

For other MCUs, this behaviour is different: DQ7 outputs ‘0’ already in ‘sector erase wait’ state.

This behaviour of the DQ7 flag is not described correctly or precisely in all hardware manuals. If the software only polls the DQ7 flag to detect the ‘erase completion’, then the software could misinterpret the ‘sector erase wait’ state as ‘erase completion’ in affected MCUs, although such software works correctly in other MCUs.

As a result, the CPU may start fetching instruction/data from flash during 'sector erase' and may misinterpret the hardware sequence flags as instruction/data, causing abnormal operation. Or the CPU tries to submit a second command which is not accepted by the flash or which accidentally puts the flash into 'sector erase suspend' state.
