Fujitsu Microelectronics Europe
Functional Limitation Report

32-BIT MICROCONTROLLER **MB91460 SERIES**

MB91V460
FUNCTIONAL LIMITATION
DMA FLASH INTERFACE ARBITRATION
2008-10-06

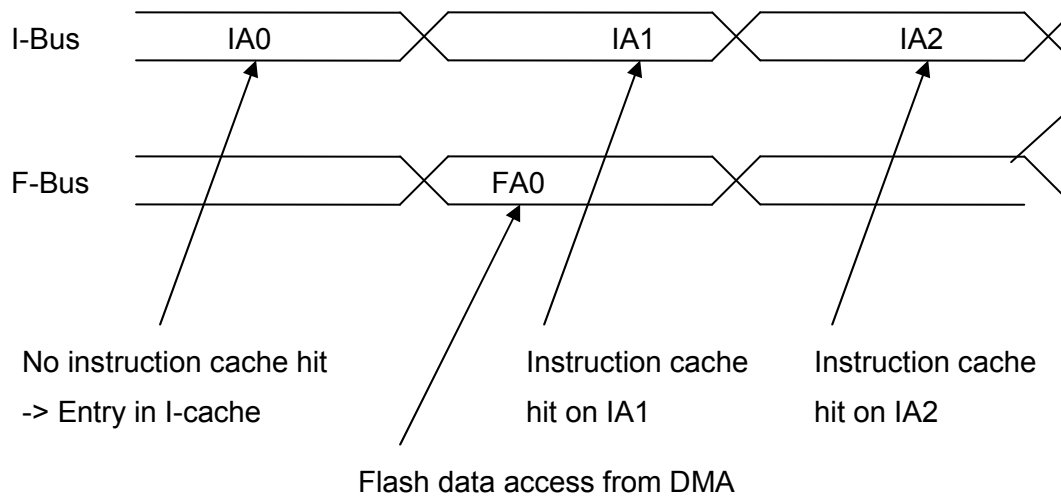
In contrast when using the DMA to transfer data from Flash memory: in that case due to continuous program operation a subsequent instruction cache hit can occur after the first instruction hit. Here the problem can occur depending on exact timing of instruction hits and DMA access.

- CLKB Cycle 1: Instruction #IA0 output from flash -> write to I-Cache
- CLKB Cycle 2: I-Cache RAM read-after-write wait cycle
F-bus data access from DMA to Flash in parallel,
causing the problem.
- CLKB Cycle 3: I-cache hit on instruction #IA1
- CLKB Cycle 4: I-cache hit on instruction #IA2
- CLKB Cycle n: Wrong output of instruction #IA3 to I-Bus and/or entry to I-Cache
