Errata

This errata sheet is for MB91270 Series Hardware Manual Rev.2 (CM71-10128-2E)

FR60Lite
 32-BIT MICROCONTROLLER
 MB91270 Series
 HARDWARE MANUAL

Addendum, MB91270 Hardware Manual (CM71-10128-2E)

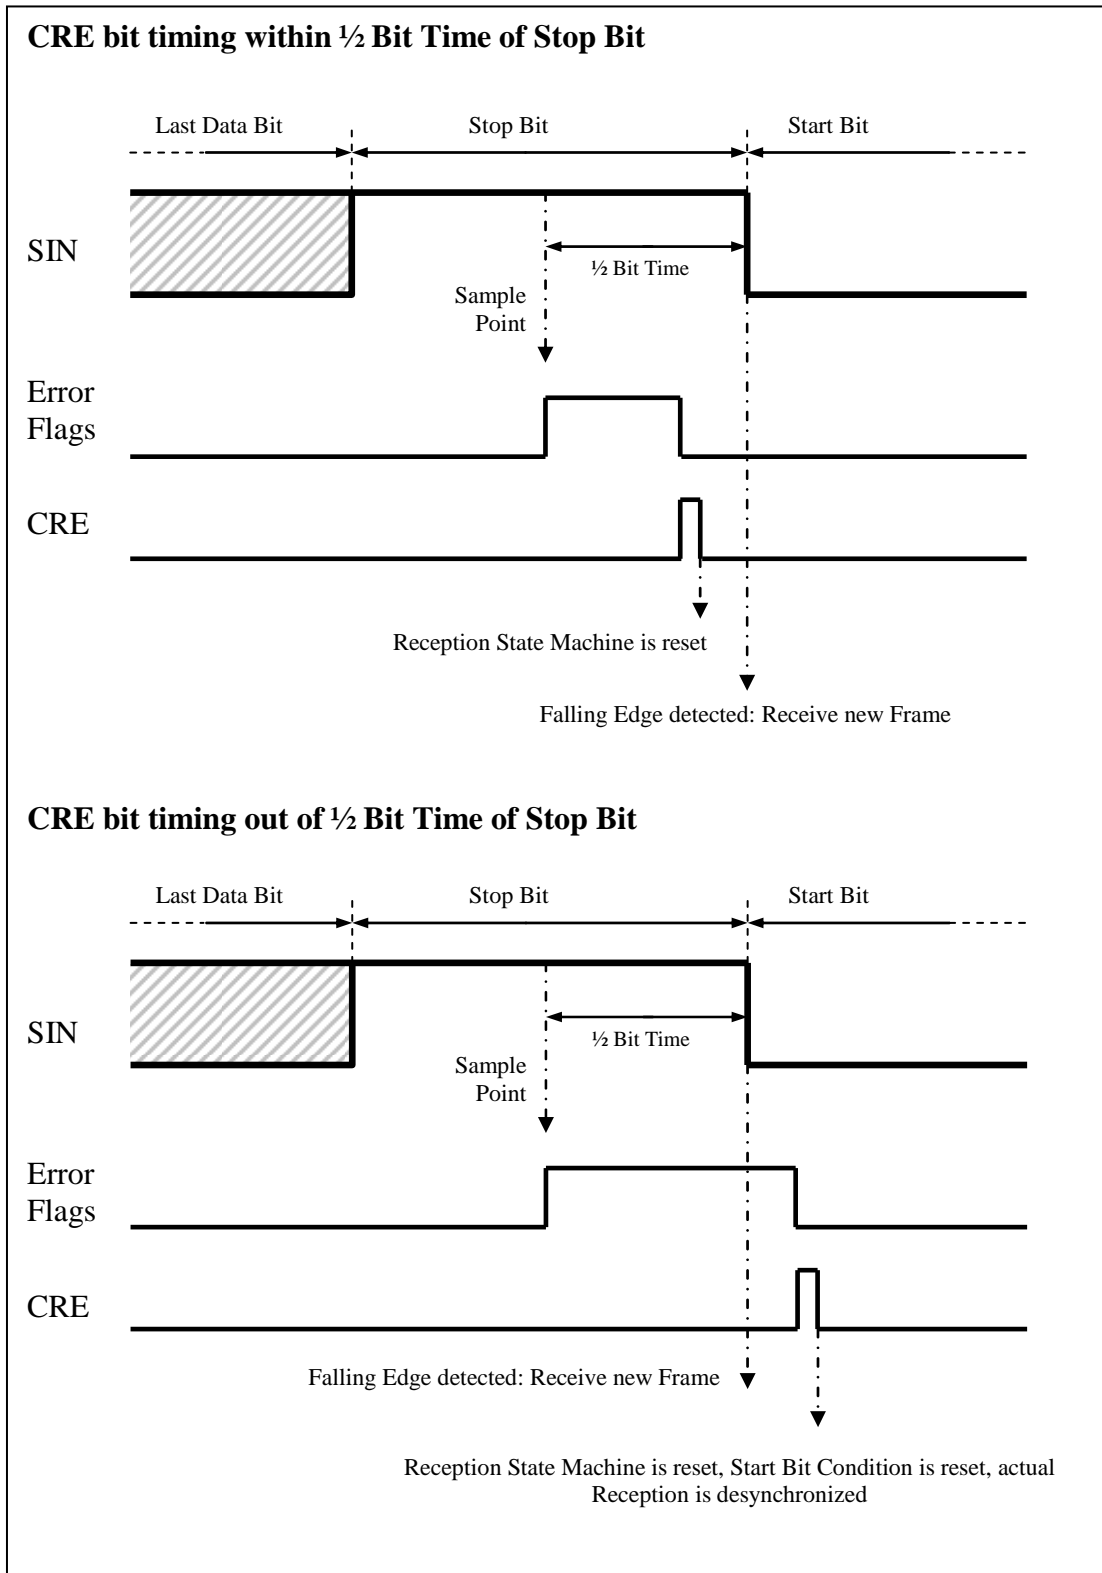
Graphic 1:

- 1) (Graphic 1) CRE resets reception state machine and next falling edge at SINn starts reception of new byte (graphic 1).

Therefore either set CRE bit immediately (within half bit time) after receiving errors to prevent data stream desynchronization (Graphic 2) or wait an application dependent time after receiving errors and set CRE, when SINn is idle.

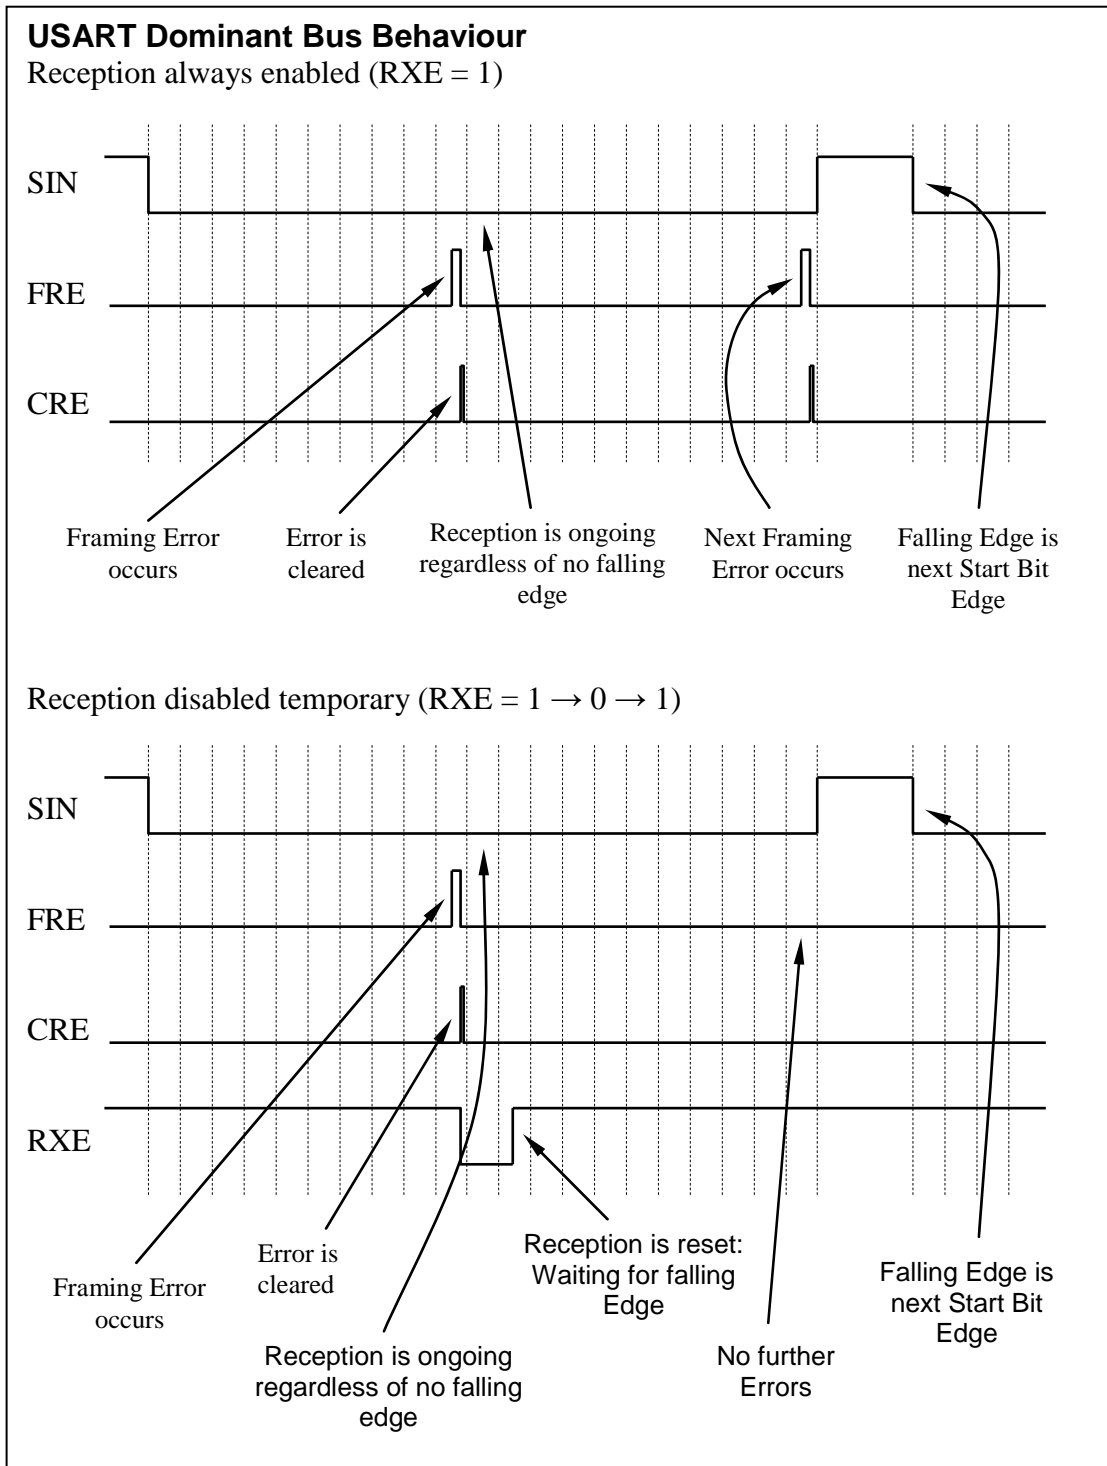
Graphic 3:

- 2) Please note, that in case a framing error occurred (stop bit: SINn = "0") and next start bit (SINn = "0") follows immediately, this start bit is recognized regardless of no falling edge before (Graphic 3). This is used to remain UART synchronized to the data stream and to detect that serial data input (SINn) keeps "L" level (Graphic 3 above) by producing next framing errors. If this behavior is not wanted, please disable the reception temporarily RXE = 1 -> 0 -> 1 after framing error. In this case, reception goes on at next falling edge on SINn. (Graphic 3 below).
